# Detection of Damage during Quasi-Static Loading of a Single Stringer Panel using Passive Thermography and Acoustic Emission

Mr. Joseph N. Zalameda<sup>1</sup>, Dr. William P. Winfree<sup>1</sup>, and Dr. Michael R. Horne<sup>2</sup>

<sup>1</sup>NASA Langley Research Center, MS231 Hampton, VA 23681

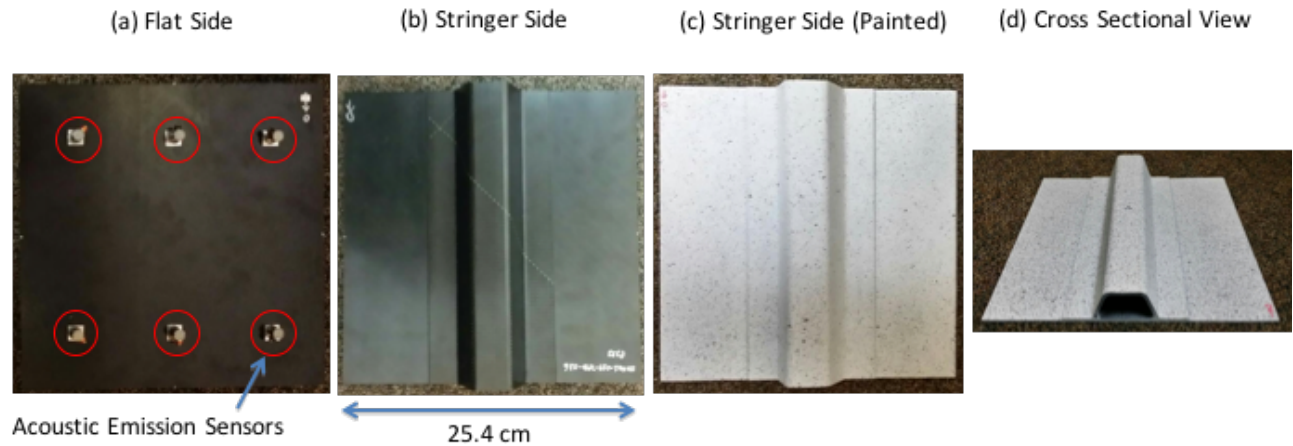
The stiffened composite panel skin is 12 plies with a thickness of 0.22cm, the stiffener flange is 12 plies thick with a thickness of 0.24cm. The stiffener is a woven composite. The stiffened composite panel flat side, stringer side with acoustic emission locations, the painted specimen, and cross-sectional view are shown in Figs. 1a, 1b, 1c, and 1d respectively. The panel was painted for digital image correlation measurements to record panel deformation. Quasi-static loads were applied using seven application points, two on top (located in middle just outside of the flange) and five on the bottom (located at each corner and

Figure 1: Single stringer composite panel with acoustic emission sensor locations.

Six acoustic emission sensors were bonded to the composite panel on the skin side (shown in Fig. 1a). Each sensor was connected to a data acquisition computer via Digital Wave™ PA0 preamp/line drivers and a Digital Wave™ FM1 signal conditioning channel amplifier for capture of acoustic data at 2MHz sample rate and 1024 points per event. The acoustic emission computer also captured the load for synchronization to the thermal images. Acoustic emission systems collect structure-borne sound, typically not audible, in the ultrasonic frequency band (approx. 50 to 500 kHz), generated by dynamic displacements such as damage initiation and growth at picometer scales [11]. Pre-cursors to failure are monitored in real-time. The total signal energy,  $SE$ , of an acoustic signal is given as:

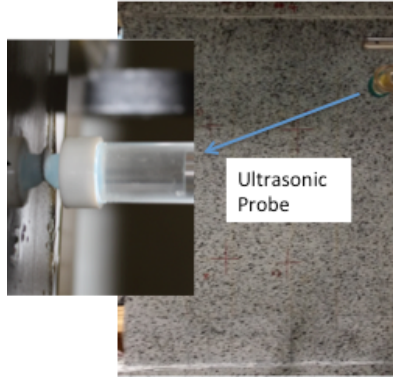
Figure 4: Close up of ultrasonic probe.

Ultrasonic inspections were implemented at intervals determined by the indication of damage growth from thermography and acoustic emission. The ultrasonic inspection technique utilizes a broadband 10 MHz transducer (1.27 cm diameter with 5.08 cm focus) contained in a captive water column with a flexible membrane tip design [12]. Water is sprayed onto the surface for ultrasonic coupling. The probe is scanned over the entire panel on the flat side. A picture of the setup is shown in Fig. 4.

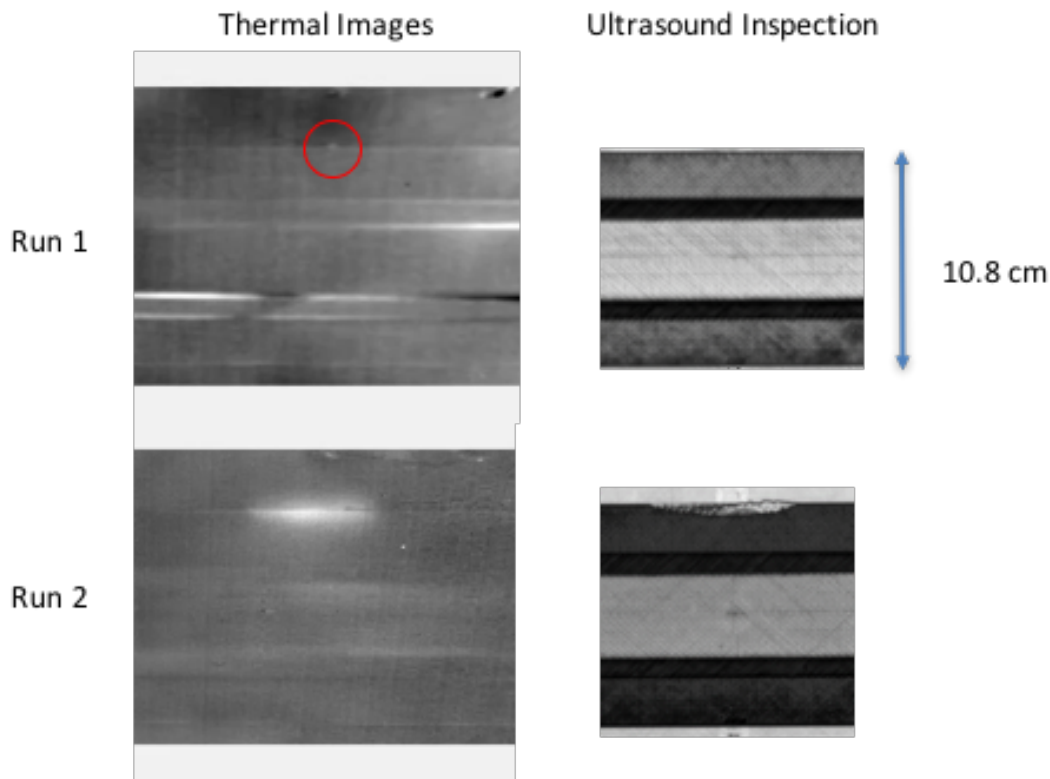
sensitivity to changes. To further remove noise, a de-noising algorithm using singular value decomposition was implemented [13,14]. Lastly, an image perspective transformation was used to correct for the infrared camera look angle since the optical line of sight was not normal [14,15]. Detected damage progression during load runs 1-4 are shown in Figs. 5, 6, and 7. The infrared image is rotated right so the top stiffener flange is the left flange of Fig. 2b. The thermal damage was detected over camera noise and background reflections using three criteria: observing a bright area that appears suddenly, stays in one location, and then slowly decays in intensity over time. When damage is detected the loading is stopped, the sample is removed, and an ultrasound inspection is performed to document the damage through-the-thickness. The respective ultrasound inspections are also shown in Figs. 5, 6, and 7. In Fig. 5, for run 1, a small thermal indication (circled in red) was detected and the resulting ultrasonic inspection revealed no damage. This was typical for several of the samples tested. A small thermal indication did not always result in detectable damage using ultrasound. The small indication in Fig. 5 could be a small matrix

Figure 5: Processed thermal inspection images for quasi-static load runs 1 and 2 with corresponding ultrasound inspection images.

crack or fiber break located at the stiffener flange edge perhaps beyond the detection limits of ultrasound. Also, any damage at this edge interface would be difficult to detect with ultrasound especially at the corner. X-ray CT inspection could be used to help understand these initial small thermal indications. The run 2 thermal image in Fig. 5 clearly shows a delamination at the stiffener flange edge. The thermal energy release due to the disbond is sufficient to generate a temperature increase sufficient to provide the general shape of the damage. The ultrasound inspection image is in agreement with the thermal indication. For load run 3 it is interesting to note the delamination growth, as indicated by the ultrasound inspection image, did not produce a sufficient temperature increase to resolve the shape and size of the damage. This is due, in all likelihood, to the delamination growing in increments from one side to another. This is plausible since the small thermal indications (circled) were detected at opposite sides of the delamination at different times as shown in Fig. 6. Shown in Fig. 7 is the final load run 4 where a large delamination was detected at the bottom as shown in the ultrasound inspection image. From the thermal inspection imagery, the top delamination appeared to grow only slightly on the left side. From the ultrasonic image, the top delamination appeared to grow slightly and then result in a sudden bottom failure. At 3.33 seconds, there appears to be a single layer failure (circled) at the skin leading into the stiffener flange. At 3.88 seconds, there is a large thermal indication that appears showing the overall shape of the delamination with good agreement as shown by the ultrasound inspection.

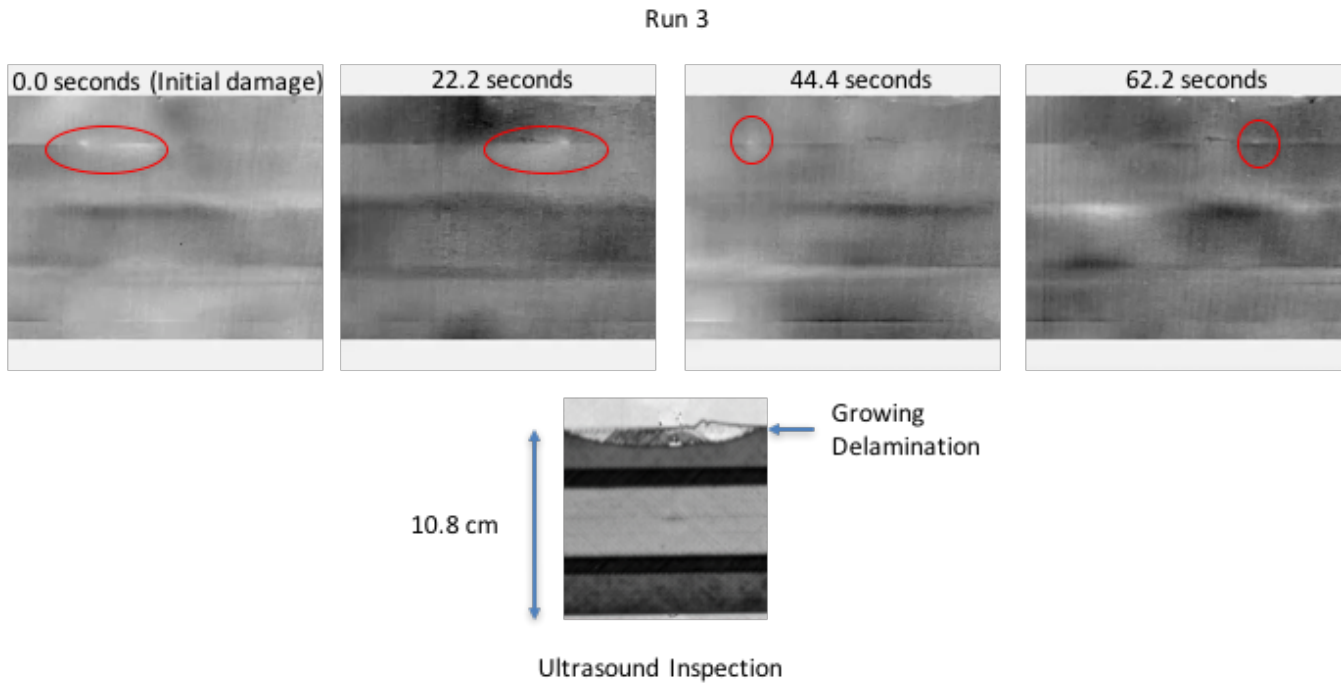
Figure 6: Processed thermal inspection images for quasi-static load run 3 with corresponding ultrasound inspection image.

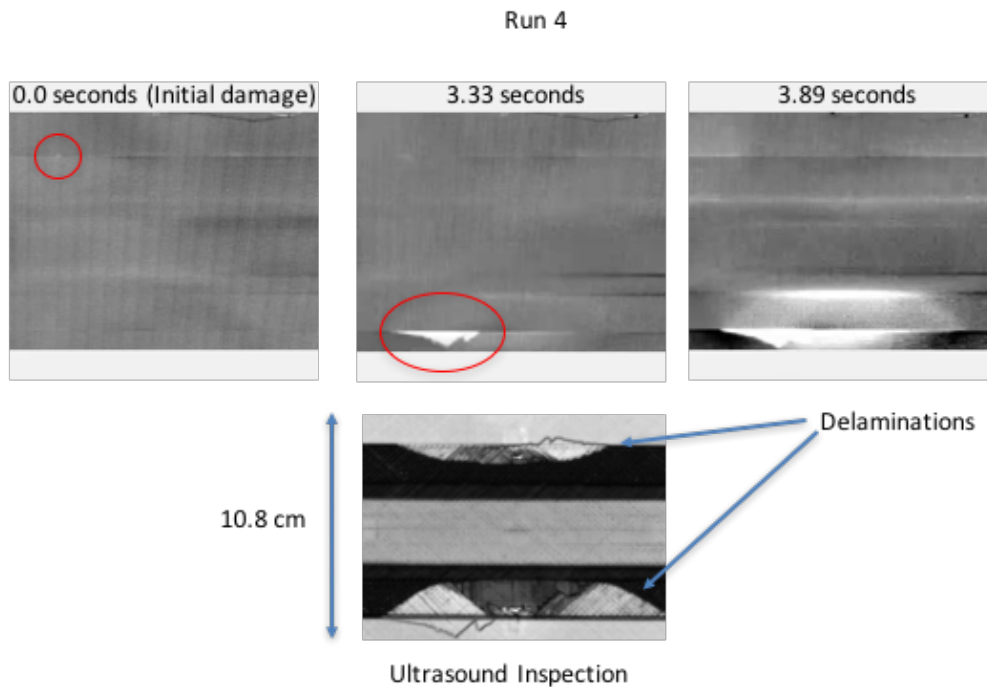
Figure 7: Processed thermal inspection images for quasi-static load run 4 with corresponding ultrasound inspection image.

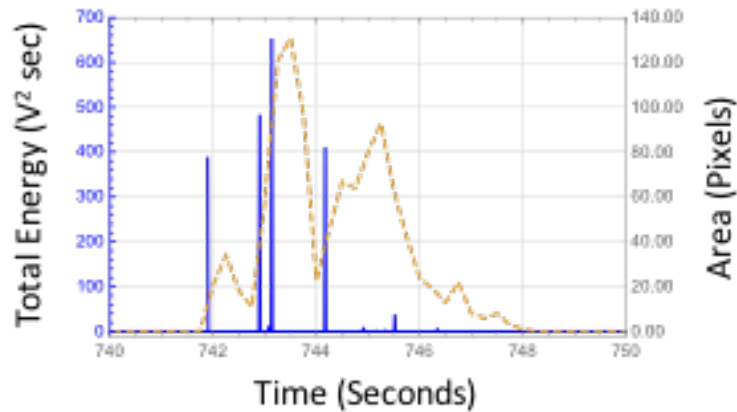
The data in Table 1 also demonstrates a consistent time delay between the acoustic emission event time and the thermal indication time. This is expected since acoustic emission detection time would be nearly instantaneous as compared to the thermal detection time. The thermal detection time requires the diffusion of heat to the surface. Another way to compare acoustic emission to passive thermography is count the number of pixels above a threshold. This is shown in Fig. 13 where the most significant acoustic emission events (energy > 100 volts<sup>2</sup> second) are compared to the thermally detected area pixels (pixel values greater than 7 counts shown in dashed line plot) as a function of time. What this clearly shows is the acoustic emission event occurs before a growth in thermally detected damage area. A failure generates an acoustic emission event and heat will take time to diffuse through-the-thickness as well as in-plane.

Figure 13: Detected acoustic emission events compared to thermally detected area pixels above a threshold.
